NATIONAL DAM SAFETY PROGRAM. PINE TREE LAKE EAST DAM (NO 30992)--ETC(U)

REPORT DOCUMENTATION PAGE		READ INSTRUCTIONS BEFORE COMPLETING FORM
1. REPORT NUMBER	2. GOVT ACCESSION NO.	3. RECIPIENT'S CATALOG NUMBER
	AD-A106452	
4. TITLE (and Subtitle) Phase I Dam Inspection Report National Dam Safety Program Pine Tree Lake East Dam (MO 30992) & West Washington County, Missouri (MO 30995)		5. TYPE OF REPORT & PERIOD COVERED Final Report

PINE TREE LAKE EAST DAM

OVERVIEW
PINE TREE LAKE WEST DAM

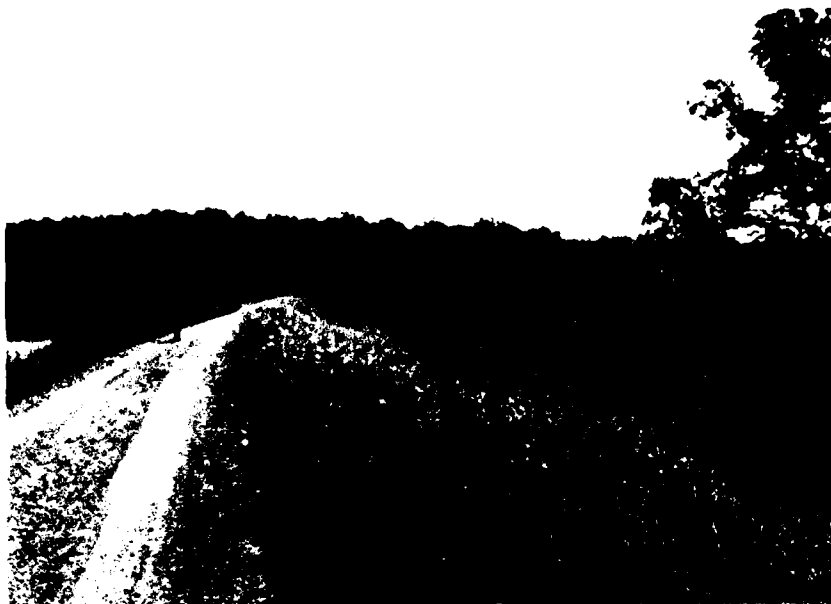
1. View of downstream slope and crest looking east. Note thick grass cover on slope.
